**T-38 FORWARD WINDSHIELD DEVELOPMENT AND PERFORMANCE
DEMONSTRATION REPORT**

J. W. MYERS
PPG INDUSTRIES, INC.
AIRCRAFT PRODUCTS
P.O. BOX 2200
HUNTSVILLE, AL 35804

March 12, 1992

Final Report for period June 1982 to September 1989

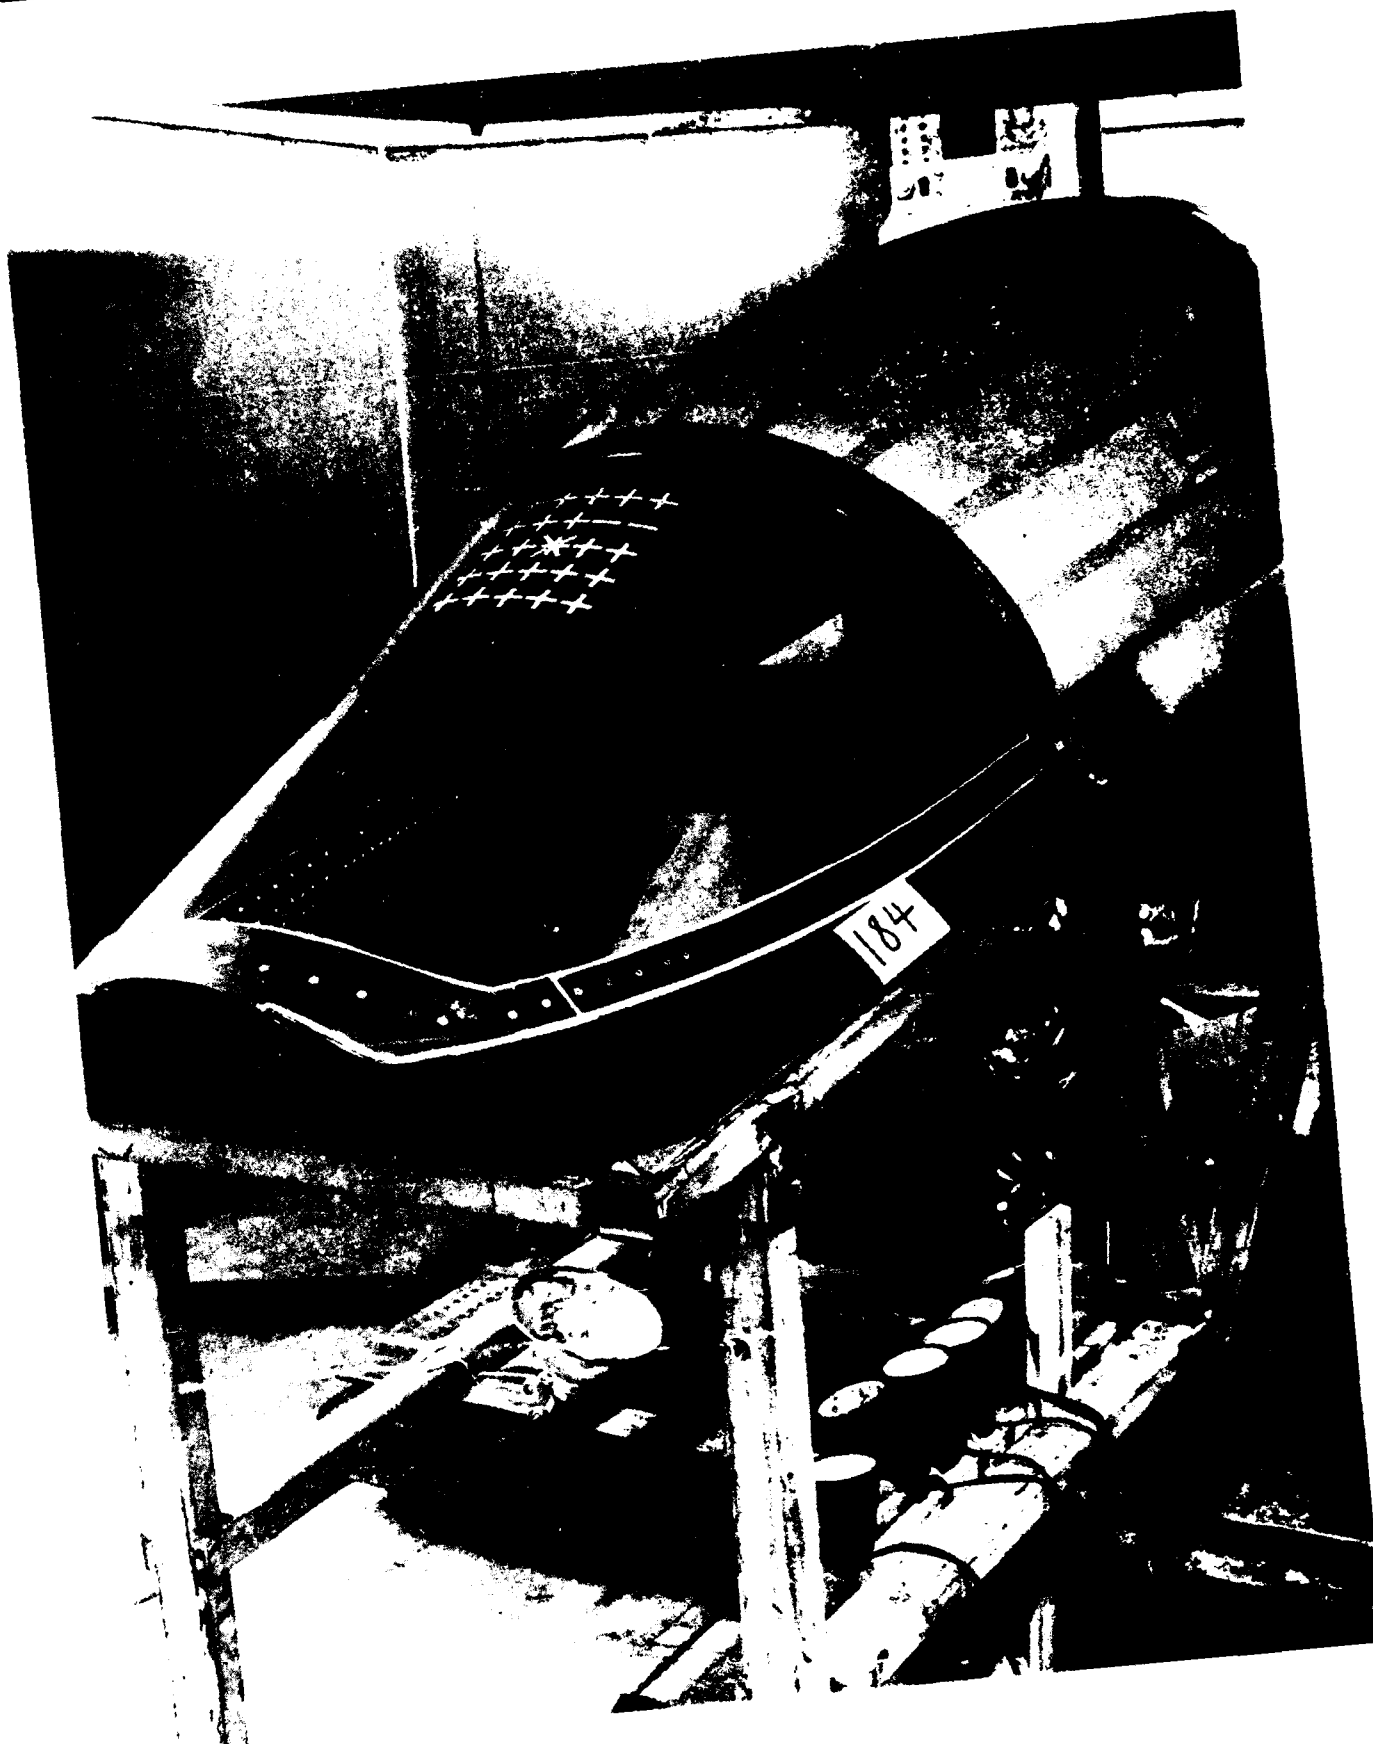
PHOTOGRAPH #1
PRE-TEST SET UP
SHOT #184

The first shot (#184) was made at 393.1-knots on windshield number 322-54 with a 4.002-pound bird at a room temperature of 70°F. The window passed with no major damage other than an approximate permanent deflection of 1/4-inch in the aft arch. Several pieces of the arch material were removed by the impact. The test also permitted a few pieces of bird residue to hit the witness plate.
